**Flood Control Project Maintenance
Levee Inspections**

Maintenance Issue Types Only, Levee Inspection Report By Mile - Fall 2016

Reclamation District No. 0501 Ryer Island

Waterway	Bank	Unit Miles	Inspection Start/End	Inspector
Unit No. 01 Steamboat Slough	Right	6.71	10/19/2016 10/19/2016	Herman Phillips

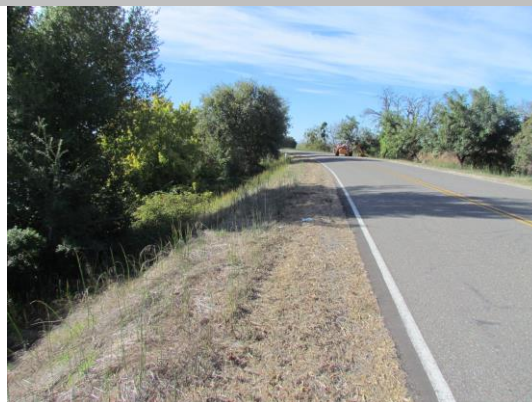
Photo 1 of 1 : FA_2016_RD0501_169_44_20161021_00060.jpg

LM Start	0.04	Rating **	M	Issue No.	44
LM End	2.81	Issue Type +	Ma	Location *	WS
Category	Earthen Levee			GPS Latitude/Longitude	
				Start	End
Item	Vegetation			38.254035 °	38.215490 °
				-121.601790 °	-121.607930 °
DWR ID	DWR_RD0501_01_f_2016_44				
Comment Code					
V2 : Remove the wild growth other than native grasses from the levee slopes.					
Inspector Comment					
RD is mowing the landside slope once that's done they will start on the waterside slope, right now there are still tall weeds that were not mowed during this inspection.

RD 501 LOOKING DOWNSTREAM levee mile 0.04-2.68.

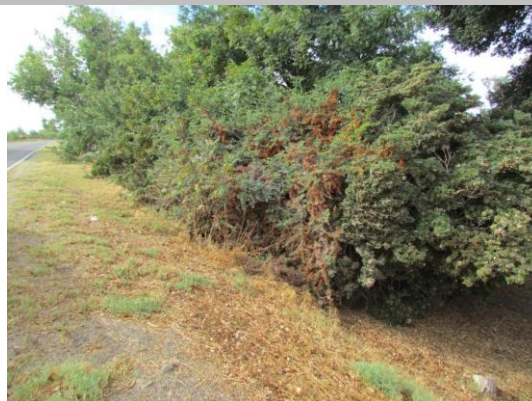
Photo 1 of 1 : FA_2016_RD0501_169_116_20161018_00010.jpg

LM Start	2.31	Rating **	M	Issue No.	116
LM End	2.31	Issue Type +	Ma	Location *	LS
Category	Earthen Levee			GPS Latitude/Longitude	
				Start	End
Item	Trim / Thin Trees			38.221620°	38.221620°
				-121.603390°	-121.603393°
DWR ID	DWR_RD0501_01_f_2014_116				
Comment Code					
T1 : Trim trees to at least five feet above ground level.					
Inspector Comment					
Continue trimming the trees growth at this location to at least five feet above the ground.

Looking downstream at the woody tree growth on the landward levee slope. No new photo taken.

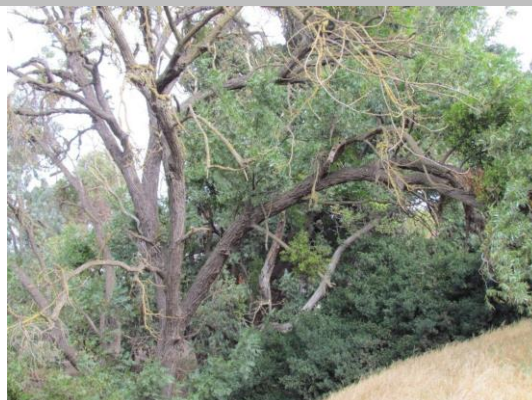
Photo 1 of 1 : FA_2016_RD0501_169_6_20161018_00005.jpg

LM Start	2.32	Rating **	U	Issue No.	6
LM End	2.32	Issue Type +	Ma	Location *	LS
Category	Earthen Levee			GPS Latitude/Longitude	
				Start	End
Item	Trim / Thin Trees			38.221455 °	38.221455 °
				-121.603508 °	-121.603508 °
DWR ID	DWR_RD0501_01_f_2015_6				
Comment Code					
T1 : Trim trees to at least five feet above ground level.					
Inspector Comment					
This tree at this location is dead and poses a threat that could cause injury to persons or levee damage. No new photo taken.

This photo shows an old dead cotton wood tree at the landside levee toe.

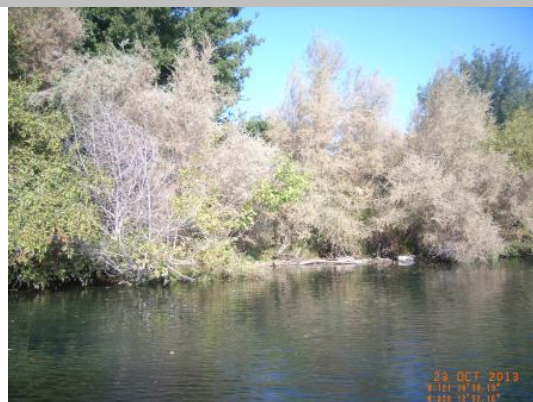
Photo 1 of 1 : FA_2016_RD0501_169_3_20161018_00003.jpg

LM Start	2.85	Rating **	M	Issue No.	3
LM End	2.91	Issue Type +	Ma	Location *	WS
Category	Supplemental			GPS Latitude/Longitude	
				Start	End
Item	2015 USACE Erosion Survey, DRAFT			38.214838 °	38.214075 °
				-121.608129 °	-121.608750 °
DWR ID	DWR_RD0501_01_f_2016_3				
Comment Code					
Inspector Comment					
2009 - Rock is starting to unravel, probably from a tree pop-out, hard toe. 2015: No observed changes. [2015 Site ID: STM_18-9_R]

USACE 2013 Photo #1

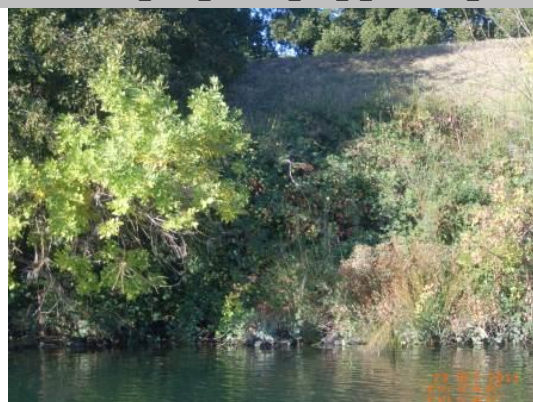
Photo 1 of 1 : FA_2016_RD0501_169_2_20161018_00002.jpg

LM Start	3.04	Rating **	M	Issue No.	2
LM End	3.11	Issue Type +	Ma	Location *	WS
Category	Supplemental			GPS Latitude/Longitude	
				Start	End
Item	2015 USACE Erosion Survey, DRAFT			38.212573 °	38.211596 °
				-121.609760 °	-121.609928 °
DWR ID	DWR_RD0501_01_f_2016_2				
Comment Code					
Inspector Comment					
2000 - Slow erosion of lower and mid-slope with rock bench at the low water line. 2015: No observed changes. [2015 Site ID: STM_18-8_R]

USACE 2013 Photo #1

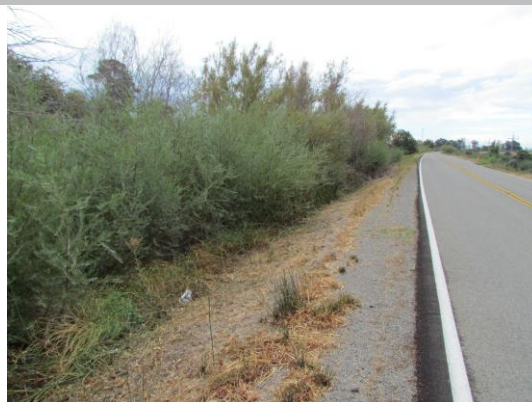
Photo 1 of 1 : FA_2016_RD0501_169_974_20161018_00012.jpg

LM Start	3.73	Rating **	U	Issue No.	974
LM End	4.12	Issue Type +	Ma	Location *	WS
Category	Earthen Levee			GPS Latitude/Longitude	
				Start	End
Item	Vegetation			38.202997 °	38.197778 °
				-121.613450 °	-121.616080 °
DWR ID	DWR_RD0501_01_s_2012_974				
Comment Code					
V2 : Remove the wild growth other than native grasses from the levee slopes.					
Inspector Comment					
Remove the wild growth from the waterside slope.

Unsatisfactory wild tree growth on the waterside slope. No new photo.

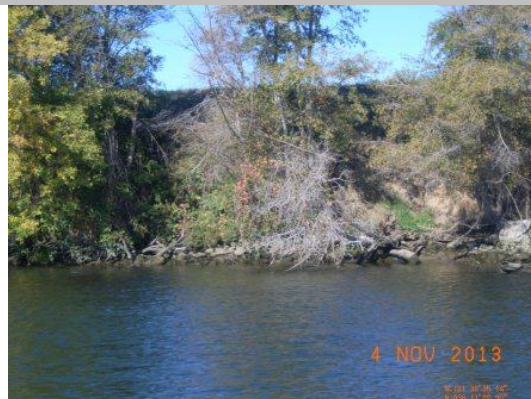
Photo 1 of 1 : FA_2016_RD0501_169_1_20161018_00001.jpg

LM Start	5.77	Rating **	M	Issue No.	1
LM End	5.84	Issue Type +	Ma	Location *	WS
Category	Supplemental			GPS Latitude/Longitude	
				Start	End
Item	2015 USACE Erosion Survey, DRAFT			38.190001°	38.189311°
				-121.643160°	-121.643917°
DWR ID	DWR_RD0501_01_f_2016_1				
Comment Code					
Inspector Comment					
2008 - Overstepped levee section with multiple small pockets of erosion 10 - 20 ft wide. 2013 - Site has fresh erosion and taller vertical sections. 2015: No observed changes. [2015 Site ID: STM_15-7_R]

USACE 2013 Photo #1

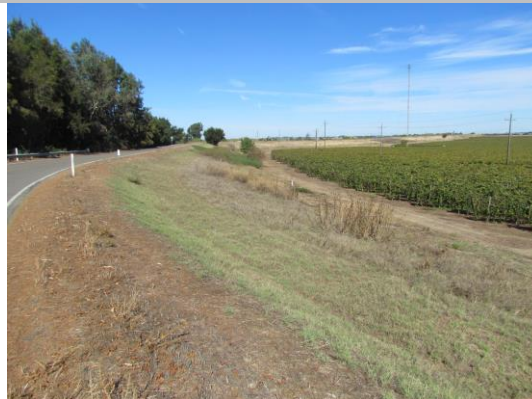
Photo 1 of 1 : FA_2016_RD0501_170_24_20161024_00043.jpg

LM Start	0.01	Rating **	A	Issue No.	24
LM End	3.55	Issue Type +	Ma	Location *	LS
Category	Earthen Levee			GPS Latitude/Longitude	
				Start	End
Item	Vegetation			38.184110 °	38.227787 °
				-121.658015 °	-121.673103 °
DWR ID	DWR_RD0501_02_f_2016_24				
Comment Code					
V1 : Control annual grass and weeds on the levee slopes and easements.					
Inspector Comment					
The RD is mowing the landside levee slope and toe during this inspection.

RD 501 Unit 2 levee mile 0.00 -3.55 landside looking downstream of levee slope.

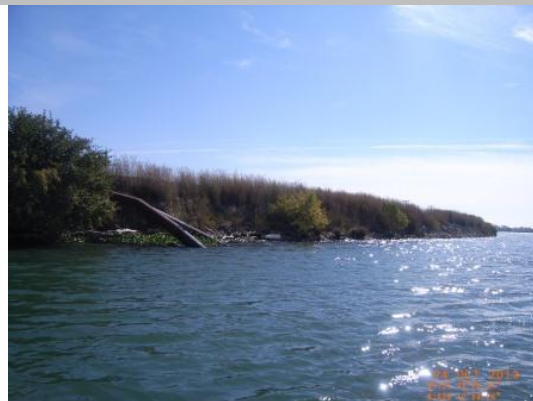
Photo 1 of 1 : FA_2016_RD0501_170_1_20161018_00001.jpg

LM Start	1.10	Rating **	M	Issue No.	1
LM End	1.17	Issue Type +	Ma	Location *	WS
Category	Supplemental			GPS Latitude/Longitude	
				Start	End
Item	2015 USACE Erosion Survey, DRAFT			38.199128°	38.200146°
				-121.655881°	-121.655638°
DWR ID	DWR_RD0501_02_f_2016_1				
Comment Code					
Inspector Comment					
2005 - Large vertical sections due to wave wash. New stone dumped on the bank with exposed geotextile. Cohesive toe has thin weak stratigraphic unit that is washing out. 2006 - Partially repaired, but 100 ft in the middle of the reach has exposed filter fabric and stone riprap is gone. 2010 - Site extended downstream to include new erosion pocket. 2015: No observed changes. [2015 Site ID: CHS 15-9 L]

USACE 2013 Photo #1

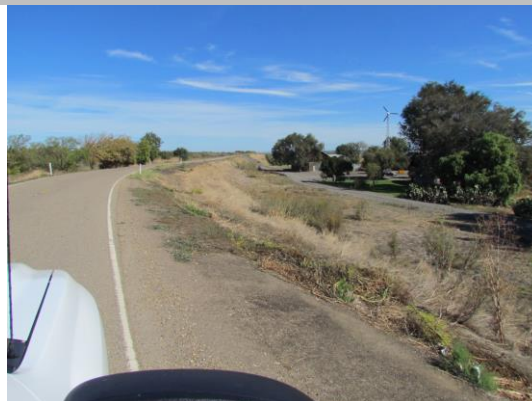
Photo 1 of 1 : FA_2016_RD0501_171_32_20161021_00068.jpg

LM Start	0.01	Rating **	A/W	Issue No.	32
LM End	7.70	Issue Type +	Ma	Location *	LS
Category	Earthen Levee			GPS Latitude/Longitude	
				Start	End
Item	Vegetation			38.228207°	38.285530°
				-121.673012°	-121.606210°
DWR ID	DWR_RD0501_03_f_2016_32				
Comment Code					
V1 : Control annual grass and weeds on the levee slopes and easements.					
Inspector Comment					
RD 501 has mowing crew on levee chopping the weeds on landside from levee mile 0.01-7.70 top and bottom of slope.

RD 501 Unit 3 looking downstream landside slope levee mile 0.01 -7.70.

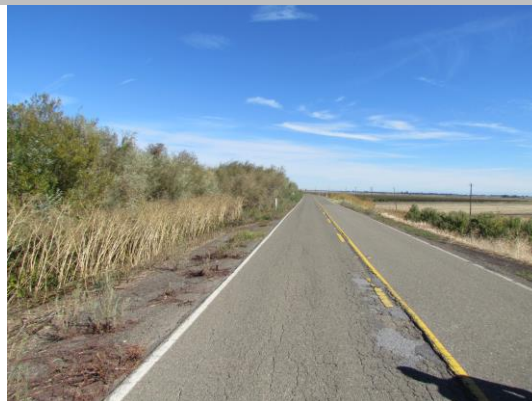
Photo 1 of 1 : FA_2016_RD0501_171_35_20161021_00069.jpg

LM Start	0.51	Rating **	U	Issue No.	35
LM End	0.61	Issue Type +	Ma	Location *	WS
Category	Earthen Levee			GPS Latitude/Longitude	
				Start	End
Item	Vegetation			38.233410°	38.234525°
				-121.666788°	-121.665495°
DWR ID	DWR_RD0501_03_f_2016_35				
Comment Code					
V7 : Trees / Woody Vegetation					
Inspector Comment					
Thin out the woody tree growth on the waterside slope.

RD 501 Unit 3 levee mile 0.51 downstream to 0.61 waterside shoulder and slope.

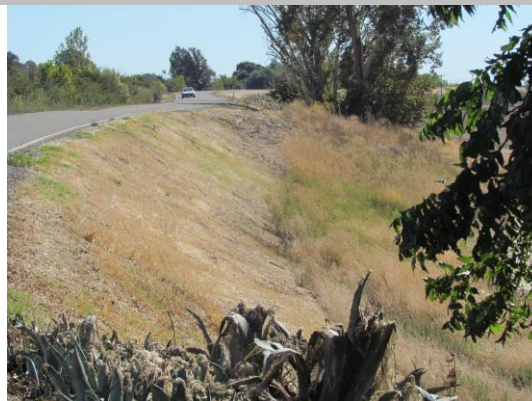
Photo 1 of 1 : FA_2016_RD0501_172_15_20161021_00029.jpg

LM Start	0.00	Rating **	A/W	Issue No.	15
LM End	2.27	Issue Type +	Ma	Location *	LS
Category	Earthen Levee			GPS Latitude/Longitude	
				Start	End
Item	Vegetation			38.285418 °	38.254622 °
				-121.606028 °	-121.601385 °
DWR ID	DWR_RD0501_04_f_2016_15				
Comment Code					
V1 : Control annual grass and weeds on the levee slopes and easements.					
Inspector Comment					
RD is in process of mowing the landside slope working downstream.

RD 501 Unit 4 looking downstream from levee mile 0.00- 2.27 landside slope.
